# Leak detection in underground pipelines of municipal water distribution

*Source / Izvornik:* **ATDC'05 Proceedings of the 4th DAAAM International Conference on Advanced Technologies for Developing Countries, 2005, 481 - 486**

**Conference paper / Rad u zborniku**

## LEAK DETECTION IN UNDERGROUND PIPELINES OF MUNICIPAL WATER DISTRIBUTION

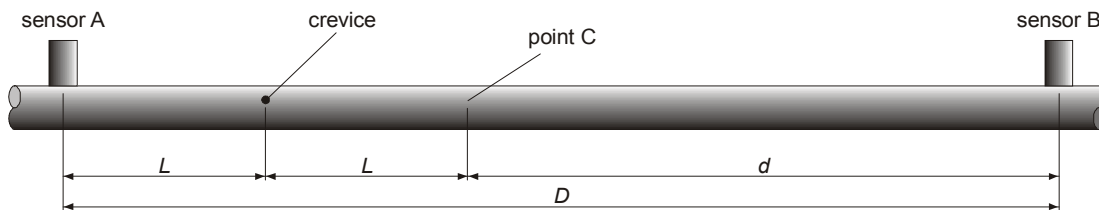
**Figure 7 Crevice and correlator sensors positions**

With Correlator the operator detects the leak macro location [6]. The measuring method is based on the analyses of the noise caused by water flow through the crevice, from high pressure zone in the pipelines to low pressure zone in the ground. The noise sound waves travel through the pipelines from the crevice in both directions at a time. Macro location of the crevice is determined by the correlation analyses of the times needed for the sound to attain two different points (Figure 7).

Distance  $L$  (Figure 7) can be calculated from:

$$L = \frac{D - v \cdot T_d}{2}$$

where:  $v$  – sound velocity, dependent on the pipe's material and diameter (Table 3)

$T_d$  – sound traveling time between points C and D
