Leak detection in underground pipelines of municipal water distribution

Source / Izvornik: **ATDC'05 Proceedings of the 4th DAAAM International Conference on Advanced Technologies for Developing Countries, 2005, 481 - 486**

LEAK DETECTION IN UNDERGROUND PIPELINES OF MUNICIPAL WATER DISTRIBUTION

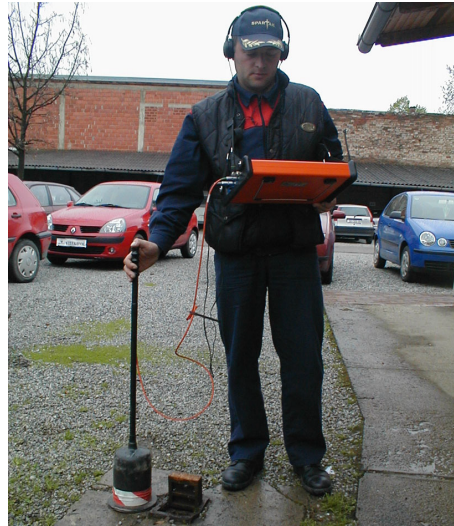
With geophone the operator detects the micro location of the leak (Figure 9, 11) by the noise "listening" [7].

Figure 9 Measurements with Geophone

The operator lays down the geophone sensor directly on the ground, listens to the noise and simultaneously watches the monitor. The louder the noise, the closer is the operator to the leak.

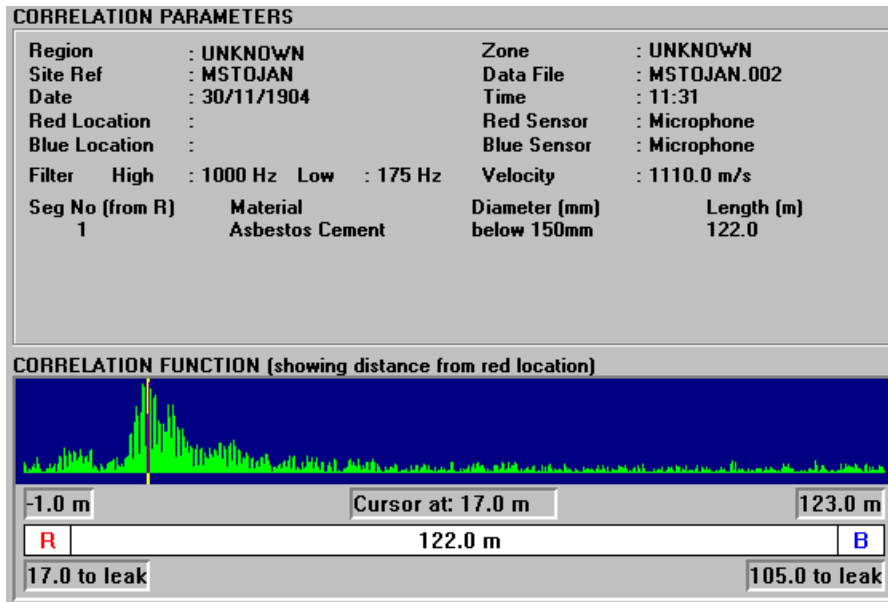
The measurement with Corelator is presented in Figure 8 and the display with measuring results in Figure 10 (noise maximum 17 m from red sensor). In the beginning of the measurement, the operator entered actual data: material/diameter/length of the pipeline, its identification and the region/zone denotation.

Figure 10 Display of the correlator

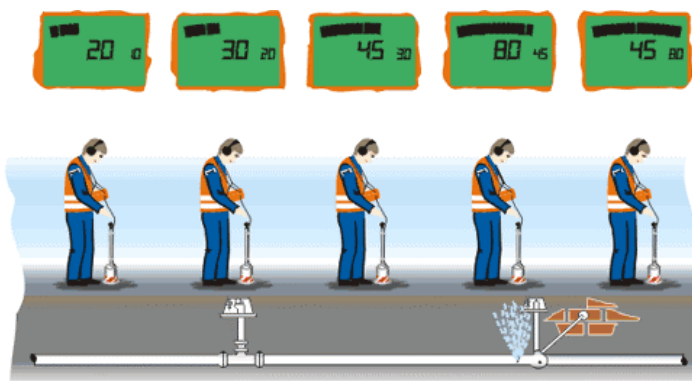
Figure 11 Geophone – function

Small leaks under high pressure usually make more noise than larger leaks under low pressure (many large leaks make almost no sound whatsoever).
