Leak detection in underground pipelines of municipal water distribution

Source / Izvornik: **ATDC'05 Proceedings of the 4th DAAAM International Conference on Advanced Technologies for Developing Countries, 2005, 481 - 486**

LEAK DETECTION IN UNDERGROUND PIPELINES OF MUNICIPAL WATER DISTRIBUTION

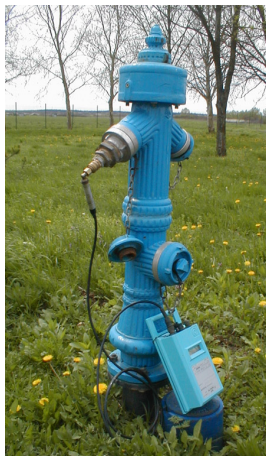
Pressure logger (Figure 5) records the water pressure in the specified time intervals [5]. The results of the pressure monitoring are presented in Figure 6. On the basis of the pressure monitoring results the conclusion about appearance of the water leakage can be drawn.

Figure 5 Pressure logger
