Conference paper / Rad u zborniku

LEAK DETECTION IN UNDERGROUND PIPELINES OF MUNICIPAL WATER DISTRIBUTION

Potable water, pipelines, leak detection

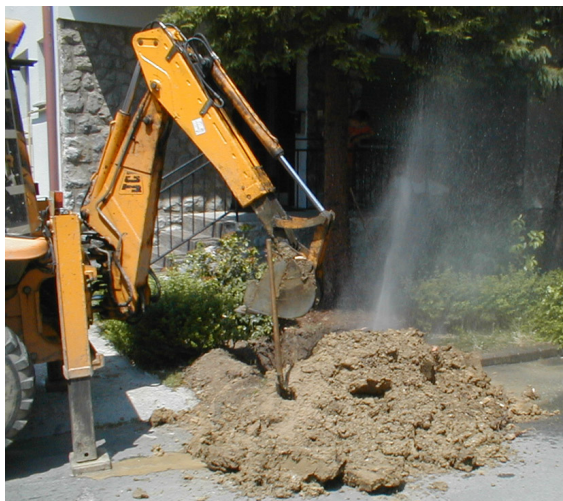
Apparent leakage is very simple to detect – it is sufficient that the water utilities controller, during regular patrol along the pipelines trace, visually establishes that water emerges. Reparation follows after that. Figure 1 shows the typical case – underground pipeline was damaged and the water emerges to the ground surface.

Figure 1 Obvious leakage of pipeline

In the case of apparent leakage, water penetrates through the ground layers above damaged place and emerges at the ground surface. The time needed for water to emerge depends on: (a) depth of the damaged parts, (b) dimension of the crevice, (b) water pressure and (c) kinds of the ground layers. This time is between several seconds and several days.

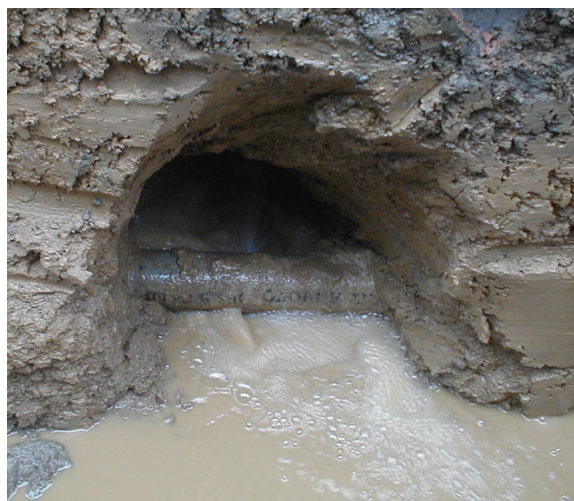
Figure 2 Hidden leakage of pipeline

Water utilities have severe difficulties with hidden leakages because they are not visually detectable. In some cases such a leakage can last many years. Professional knowledge and sophisticated equipment are necessary for the hidden leakages detection. Figure 2 shows hidden leakage with formed tunnel to the sewerage pipelines [3].

In the case of hidden leakages water swells through the municipal sewerage system. Namely, the water under pressure drills and rinses ground layers between water distribution pipelines and municipal sewerage pipelines. Through the formed tunnel and connection of the two sewerage pipes potable water flows in the sewerage.

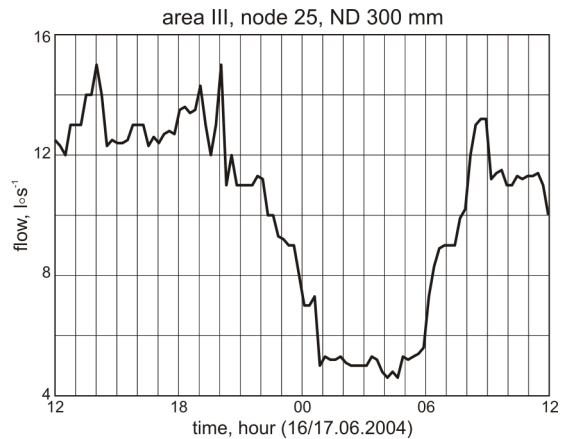
The goal of the flow rate measurement by ultrasonic flow-meter is to determine the accurate quantity of potable water flowing through the pipeline [4]. Figure 3 shows application of the ultrasonic flow-meter in case of simultaneous water flow rate measurement on two pipelines. In Figure 4 the results of 24 hour flow-rate monitoring on the pipelines ND 300 mm are presented.

Figure 4 Flow rate monitoring results

The flow decrease from daily average values of about 13 l/s to nightly average values of about 5 l/s can be seen in Figure 4. As there is no nightly industrial consumption of potable water in the area of investigation, all 5 l/h can be calculated in losses and this is the first warning that faults and/or damages on pipelines have to be looked for. The experience indicates that the sensors have to be positioned laterally to avoid the influence of the settlings separated on the pipeline bottom. Separated settlings can cause significant measuring errors and in some cases even make measurements impossible.

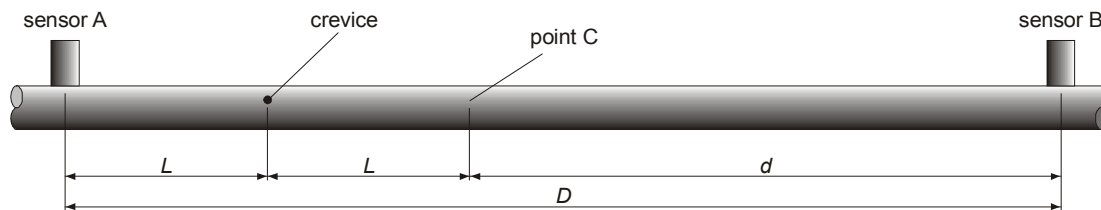
With Correlator the operator detects the leak macro location [6]. The measuring method is based on the analyses of the noise caused by water flow through the crevice, from high pressure zone in the pipelines to low pressure zone in the ground. The noise sound waves travel through the pipelines from the crevice in both directions at a time. Macro location of the crevice is determined by the correlation analyses of the times needed for the sound to attain two different points (Figure 7).

Figure 7 Crevice and correlator sensors positions

Distance L (Figure 7) can be calculated from:

$$L = \frac{D - v \cdot T_d}{2}$$

where: v – sound velocity, dependent on the pipe's material and diameter (Table 3)

T_d – sound traveling time between points C and D

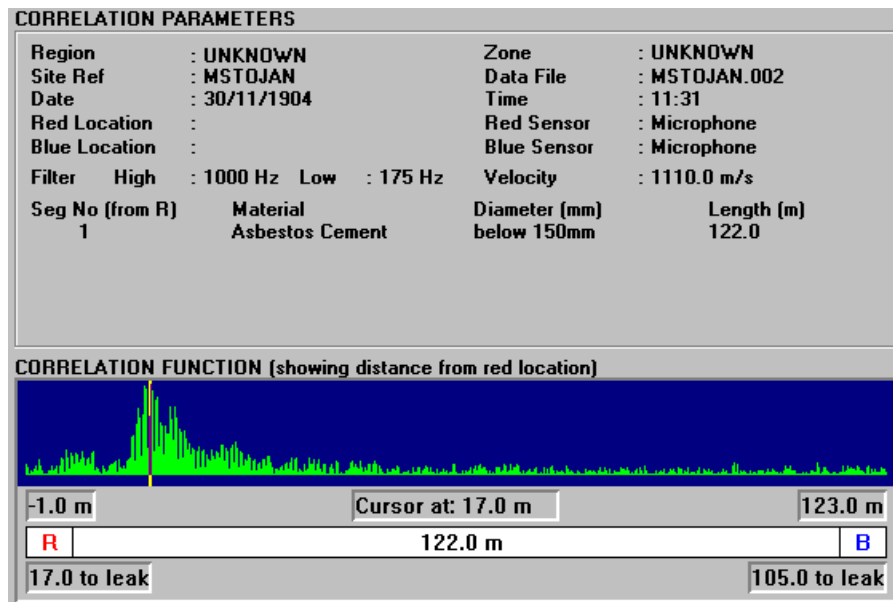
The measurement with Corelator is presented in Figure 8 and the display with measuring results in Figure 10 (noise maximum 17 m from red sensor). In the beginning of the measurement, the operator entered actual data: material/diameter/length of the pipeline, its identification and the region/zone denotation.

Figure 10 Display of the correlator

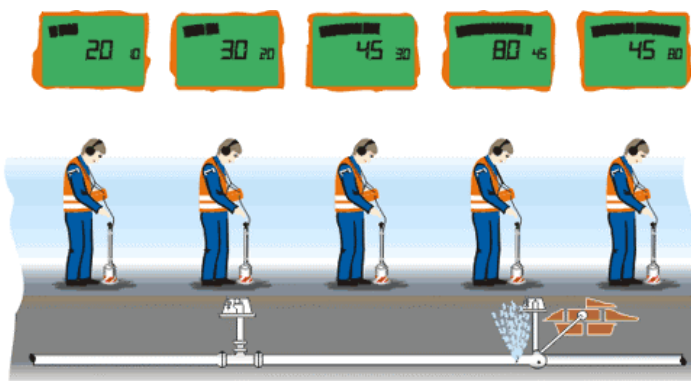
With geophone the operator detects the micro location of the leak (Figure 9, 11) by the noise "listening" [7].

Figure 11 Geophone – function

The operator lays down the geophone sensor directly on the ground, listens to the noise and simultaneously watches the monitor. The louder the noise, the closer is the operator to the leak.

Small leaks under high pressure usually make more noise than larger leaks under low pressure (many large leaks make almost no sound whatsoever).
