Source / Izvornik: **ATDC'05 Proceedings of the 4th DAAAM International Conference on Advanced Technologies for Developing Countries, 2005, 481 - 486**

LEAK DETECTION IN UNDERGROUND PIPELINES OF MUNICIPAL WATER DISTRIBUTION

Potable water, pipelines, leak detection

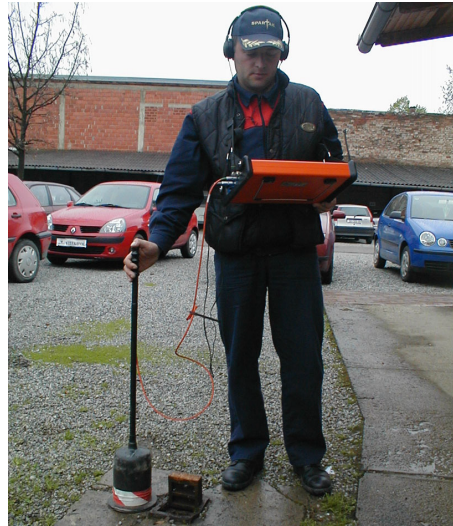
Figure 9 Measurements with Geophone

With geophone the operator detects the micro location of the leak (Figure 9, 11) by the noise "listening" [7].

The operator lays down the geophone sensor directly on the ground, listens to the noise and simultaneously watches the monitor. The louder the noise, the closer is the operator to the leak.
