# Leak detection in underground pipelines of municipal water distribution

*Source / Izvornik:* **ATDC'05 Proceedings of the 4th DAAAM International Conference on Advanced Technologies for Developing Countries, 2005, 481 - 486**

## LEAK DETECTION IN UNDERGROUND PIPELINES OF MUNICIPAL WATER DISTRIBUTION

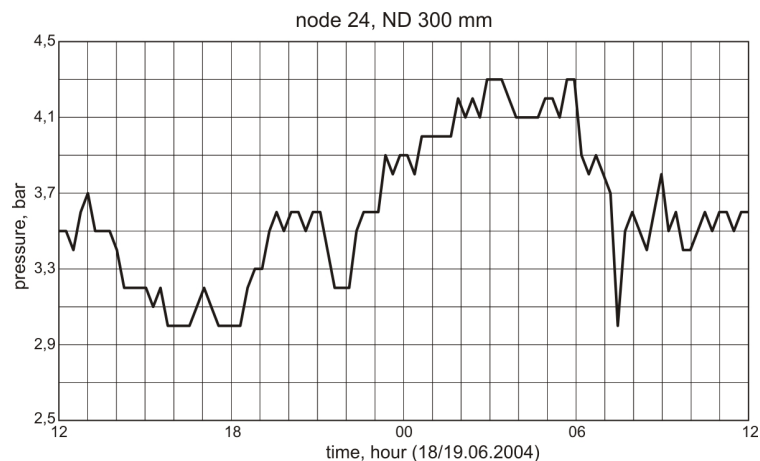
**Figure 6 Pressure monitoring results**

One effect of water leakage, besides the loss of water resources, is reduced pressure in the distribution pipelines. Relatively high values of the pressure in the night hours, between 23 and 06 hours (Figure 6), accordingly indicate that significant water leakages are not present in this area.

Pressure logger (Figure 5) records the water pressure in the specified time intervals [5]. The results of the pressure monitoring are presented in Figure 6. On the basis of the pressure monitoring results the conclusion about appearance of the water leakage can be drawn.

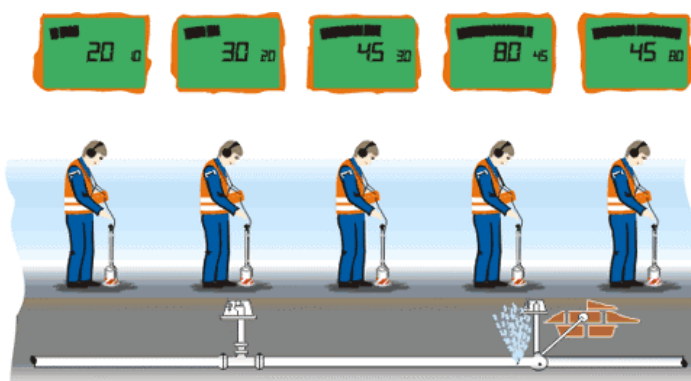
Figure 11 Geophone – function

The operator lays down the geophone sensor directly on the ground, listens to the noise and simultaneously watches the monitor. The louder the noise, the closer is the operator to the leak.

With geophone the operator detects the micro location of the leak (Figure 9, 11) by the noise "listening" [7].

Small leaks under high pressure usually make more noise than larger leaks under low pressure (many large leaks make almost no sound whatsoever).
