# Leak detection in underground pipelines of municipal water distribution

*Source / Izvornik:* **ATDC'05 Proceedings of the 4th DAAAM International Conference on Advanced Technologies for Developing Countries, 2005, 481 - 486**

## LEAK DETECTION IN UNDERGROUND PIPELINES OF MUNICIPAL WATER DISTRIBUTION

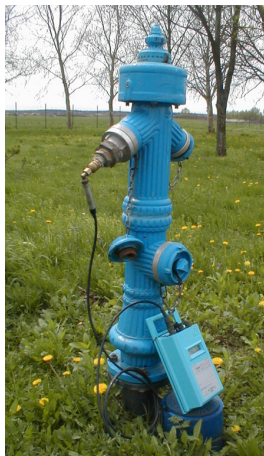
**Figure 5 Pressure logger**

Pressure logger (Figure 5) records the water pressure in the specified time intervals [5]. The results of the pressure monitoring are presented in Figure 6. On the basis of the pressure monitoring results the conclusion about appearance of the water leakage can be drawn.

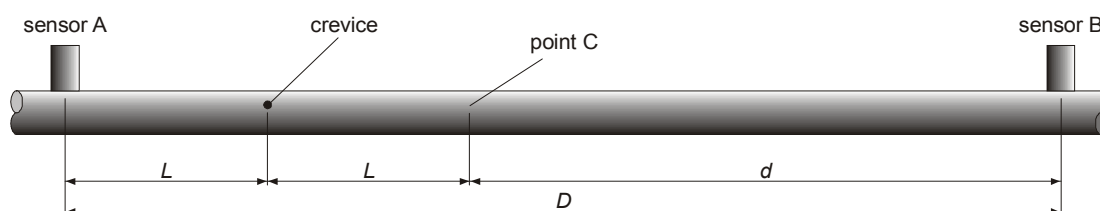
**Figure 7 Crevice and correlator sensors positions**

With Correlator the operator detects the leak macro location [6]. The measuring method is based on the analyses of the noise caused by water flow through the crevice, from high pressure zone in the pipelines to low pressure zone in the ground. The noise sound waves travel through the pipelines from the crevice in both directions at a time. Macro location of the crevice is determined by the correlation analyses of the times needed for the sound to attain two different points (Figure 7).

Distance  $L$  (Figure 7) can be calculated from:

$$L = \frac{D - v \cdot T_d}{2}$$

where:  $v$  – sound velocity, dependent on the pipe's material and diameter (Table 3)

$T_d$  – sound traveling time between points C and D
