Source / Izvornik: **ATDC'05 Proceedings of the 4th DAAAM International Conference on Advanced Technologies for Developing Countries, 2005, 481 - 486**

LEAK DETECTION IN UNDERGROUND PIPELINES OF MUNICIPAL WATER DISTRIBUTION

Potable water, pipelines, leak detection

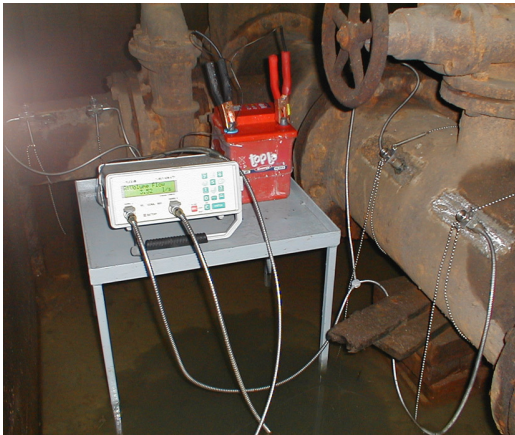
The goal of the flow rate measurement by ultrasonic flow-meter is to determine the accurate quantity of potable water flowing through the pipeline [4]. Figure 3 shows application of the ultrasonic flow-meter in case of simultaneous water flow rate measurement on two pipelines. In Figure 4 the results of 24 hour flow-rate monitoring on the pipelines ND 300 mm are presented.

Figure 3 Flow-rate measurements

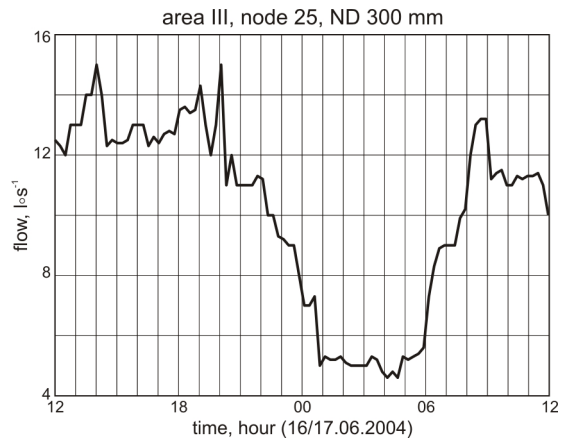
Figure 4 Flow rate monitoring results

The flow decrease from daily average values of about 13 l/s to nightly average values of about 5 l/s can be seen in Figure 4. As there is no nightly industrial consumption of potable water in the area of investigation, all 5 l/h can be calculated in losses and this is the first warning that faults and/or damages on pipelines have to be looked for. The experience indicates that the sensors have to be positioned laterally to avoid the influence of the settlings separated on the pipeline bottom. Separated settlings can cause significant measuring errors and in some cases even make measurements impossible.

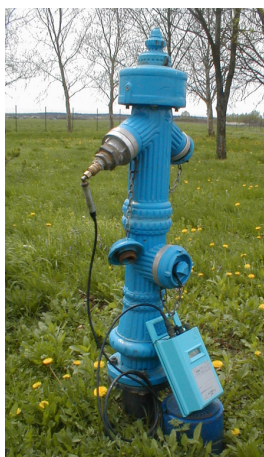
Pressure logger (Figure 5) records the water pressure in the specified time intervals [5]. The results of the pressure monitoring are presented in Figure 6. On the basis of the pressure monitoring results the conclusion about appearance of the water leakage can be drawn.

Figure 5 Pressure logger

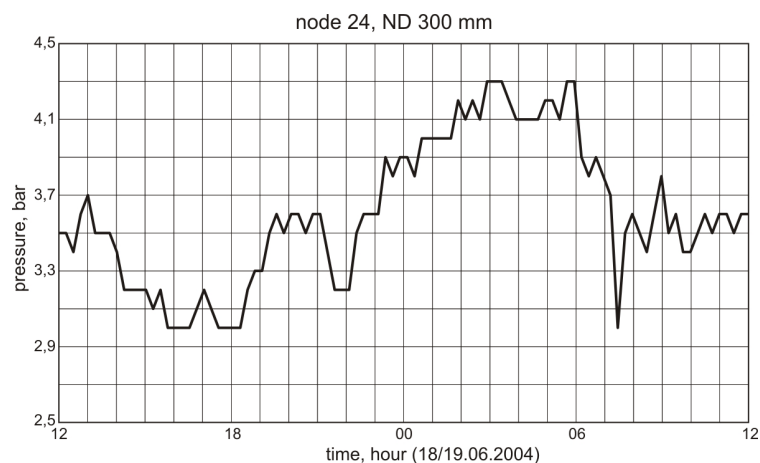
Figure 6 Pressure monitoring results

One effect of water leakage, besides the loss of water resources, is reduced pressure in the distribution pipelines. Relatively high values of the pressure in the night hours, between 23 and 06 hours (Figure 6), accordingly indicate that significant water leakages are not present in this area.

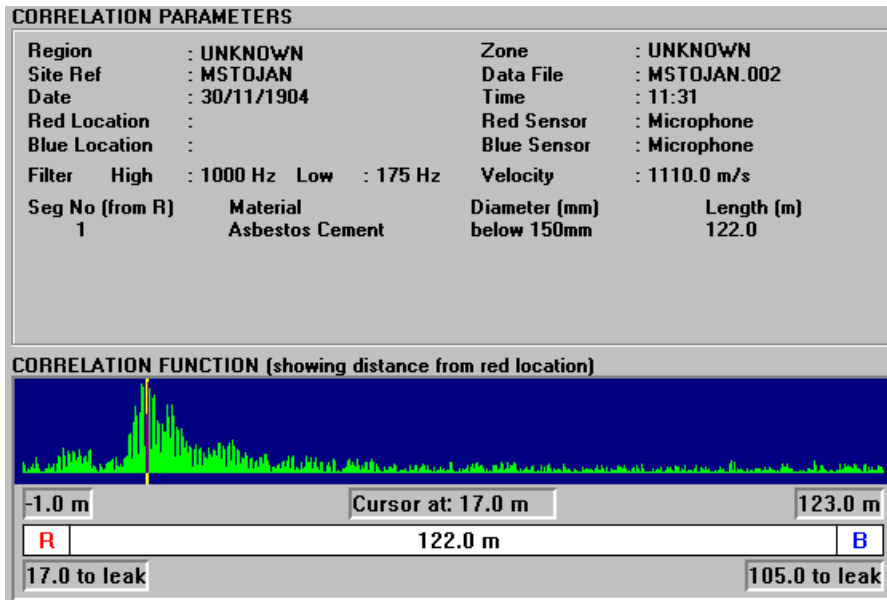
The measurement with Corelator is presented in Figure 8 and the display with measuring results in Figure 10 (noise maximum 17 m from red sensor). In the beginning of the measurement, the operator entered actual data: material/diameter/length of the pipeline, its identification and the region/zone denotation.

Figure 10 Display of the correlator

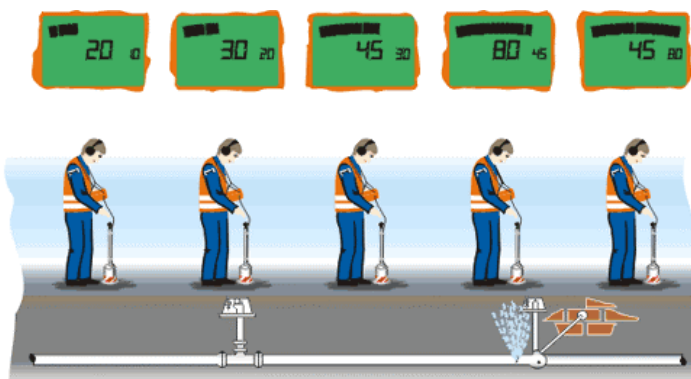
With geophone the operator detects the micro location of the leak (Figure 9, 11) by the noise "listening" [7].

Figure 11 Geophone – function

The operator lays down the geophone sensor directly on the ground, listens to the noise and simultaneously watches the monitor. The louder the noise, the closer is the operator to the leak.

Small leaks under high pressure usually make more noise than larger leaks under low pressure (many large leaks make almost no sound whatsoever).
