# Leak detection in underground pipelines of municipal water distribution

*Source / Izvornik:* **ATDC'05 Proceedings of the 4th DAAAM International Conference on Advanced Technologies for Developing Countries, 2005, 481 - 486**

*Potable water, pipelines, leak detection*

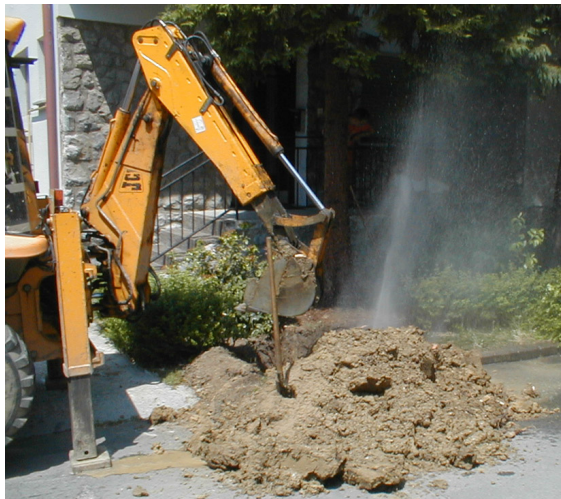
Apparent leakage is very simple to detect – it is sufficient that the water utilities controller, during regular patrol along the pipelines trace, visually establishes that water emerges. Reparation follows after that. Figure 1 shows the typical case – underground pipeline was damaged and the water emerges to the ground surface.

**Figure 1 Obvious leakage of pipeline**

In the case of apparent leakage, water penetrates through the ground layers above damaged place and emerges at the ground surface. The time needed for water to emerge depends on: (a) depth of the damaged parts, (b) dimension of the crevice, (b) water pressure and (c) kinds of the ground layers. This time is between several seconds and several days.

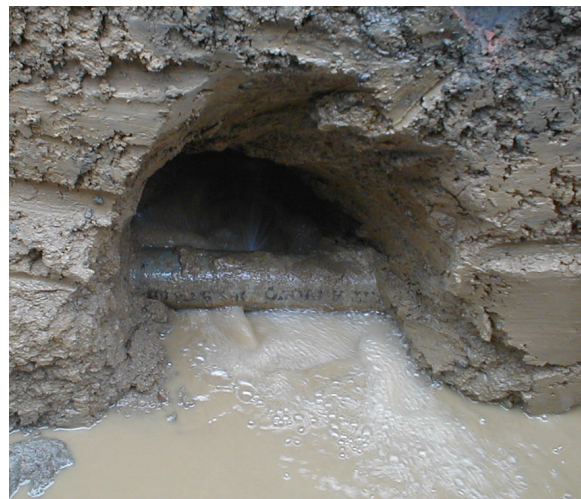
**Figure 2 Hidden leakage of pipeline**

Water utilities have severe difficulties with hidden leakages because they are not visually detectable. In some cases such a leakage can last many years. Professional knowledge and sophisticated equipment are necessary for the hidden leakages detection. Figure 2 shows hidden leakage with formed tunnel to the sewerage pipelines [3].

In the case of hidden leakages water swells through the municipal sewerage system. Namely, the water under pressure drills and rinses ground layers between water distribution pipelines and municipal sewerage pipelines. Through the formed tunnel and connection of the two sewerage pipes potable water flows in the sewerage.

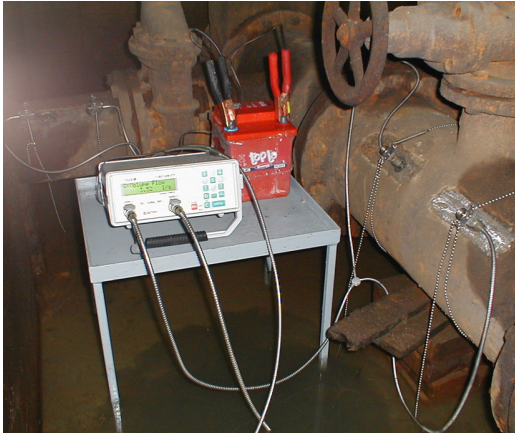
The goal of the flow rate measurement by ultrasonic flow-meter is to determine the accurate quantity of potable water flowing through the pipeline [4]. Figure 3 shows application of the ultrasonic flow-meter in case of simultaneous water flow rate measurement on two pipelines. In Figure 4 the results of 24 hour flow-rate monitoring on the pipelines ND 300 mm are presented.

**Figure 3 Flow-rate measurements**

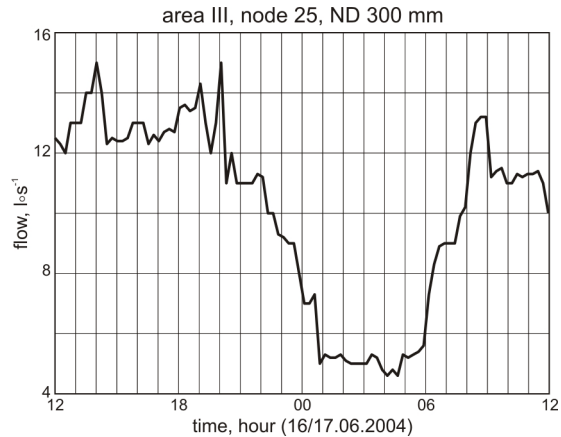
**Figure 4 Flow rate monitoring results**

The flow decrease from daily average values of about 13 l/s to nightly average values of about 5 l/s can be seen in Figure 4. As there is no nightly industrial consumption of potable water in the area of investigation, all 5 l/h can be calculated in losses and this is the first warning that faults and/or damages on pipelines have to be looked for. The experience indicates that the sensors have to be positioned laterally to avoid the influence of the settlings separated on the pipeline bottom. Separated settlings can cause significant measuring errors and in some cases even make measurements impossible.

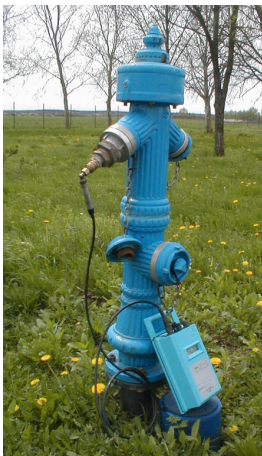
Pressure logger (Figure 5) records the water pressure in the specified time intervals [5]. The results of the pressure monitoring are presented in Figure 6. On the basis of the pressure monitoring results the conclusion about appearance of the water leakage can be drawn.

**Figure 5 Pressure logger**

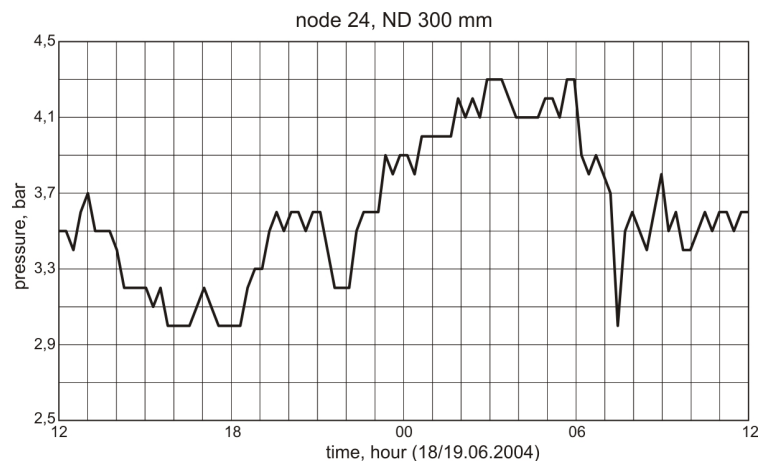
**Figure 6 Pressure monitoring results**

One effect of water leakage, besides the loss of water resources, is reduced pressure in the distribution pipelines. Relatively high values of the pressure in the night hours, between 23 and 06 hours (Figure 6), accordingly indicate that significant water leakages are not present in this area.

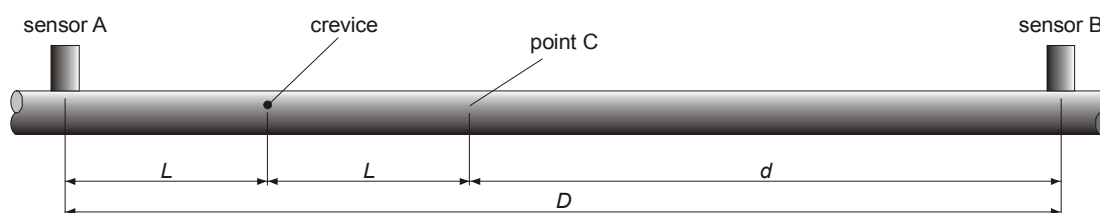
With Correlator the operator detects the leak macro location [6]. The measuring method is based on the analyses of the noise caused by water flow through the crevice, from high pressure zone in the pipelines to low pressure zone in the ground. The noise sound waves travel through the pipelines from the crevice in both directions at a time. Macro location of the crevice is determined by the correlation analyses of the times needed for the sound to attain two different points (Figure 7).

**Figure 7 Crevice and correlator sensors positions**

Distance  $L$  (Figure 7) can be calculated from:

$$L = \frac{D - v \cdot T_d}{2}$$

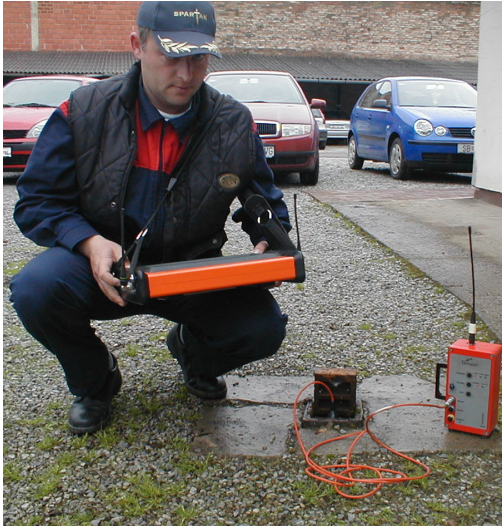
Figure 8 Measurements with Corelator

The measurement with Corelator is presented in Figure 8 and the display with measuring results in Figure 10 (noise maximum 17 m from red sensor). In the beginning of the measurement, the operator entered actual data: material/diameter/length of the pipeline, its identification and the region/zone denotation.

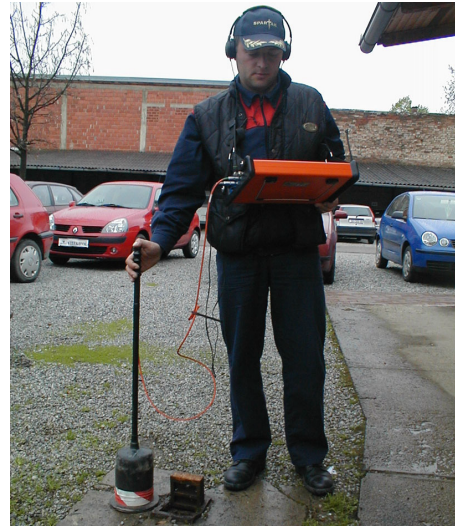
Figure 9 Measurements with Geophone

With geophone the operator detects the micro location of the leak (Figure 9, 11) by the noise "listening" [7].

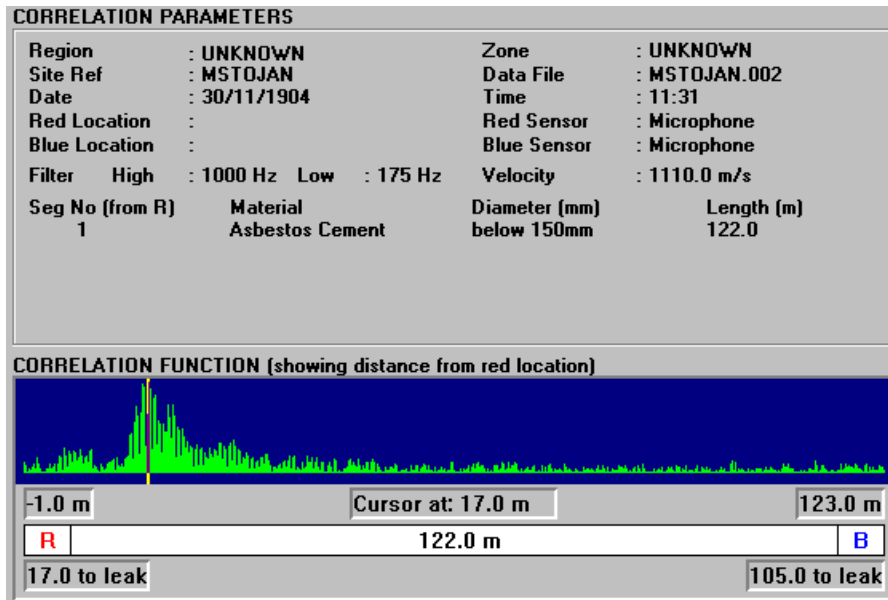
Figure 10 Display of the correlator

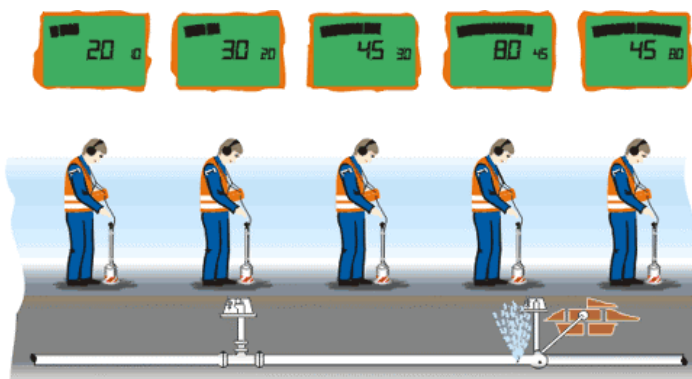
Figure 11 Geophone – function

The operator lays down the geophone sensor directly on the ground, listens to the noise and simultaneously watches the monitor. The louder the noise, the closer is the operator to the leak.
